Report: Sample report **Address:**

Confidential Inspection Report

December 28, 2009 01:30 PM.

Client:Joe Homebuyer
1245 Happy Ln
Happy Place, WA 98499**Inspection Site:**1524 Sommerset PL
Puget Sound, WA 99999**House Occupied?**

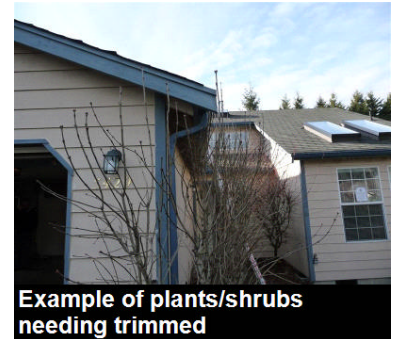
Attention Needed - The shrubs and/or bushes need to be trimmed or maintained. Usually this means that the bushes or shrubs are within 4" of the siding. A 4" gap or air space should be maintained between any plant material and the home to allow for proper air flow and to help remove the moisture. Bushes and shrubs need to be trimmed away from the structure at least 2 inches. This space is needed to prevent direct access to the structure by insects and to keep the bushes from damaging the siding.

Example of plants/shrubs needing trimmed

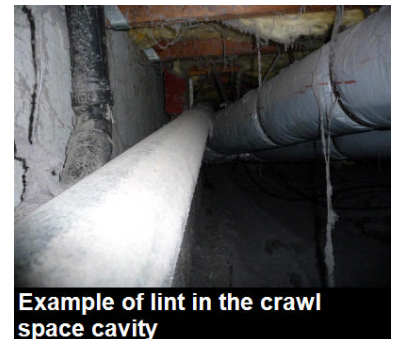
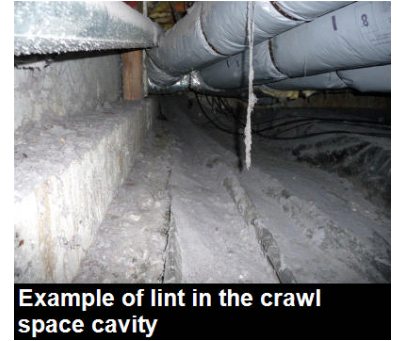
Soil. The crawl space cavity has a substantial amount of lint on top of the vapor barrier and some of the ducts. This was caused by a disconnected dryer vent. Exposed lint is considered a fire hazard and needs to be cleaned from the crawl space area.

Example of lint in the crawl space cavity

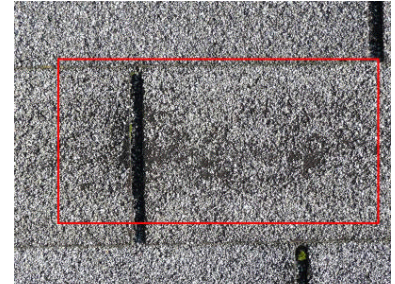
The roof shingles appear to be original to the home. The shingles that are installed are a 20 yr 3-tab design. Some of the shingles have been replaced and there is visible evidence of shingle deterioration (granule loss). Much of the roof has a moss covering which could indicate that the shingles are no longer shedding the water as intended. I recommend that a qualified roofer(s), offer an estimate for replacement.

Granule loss

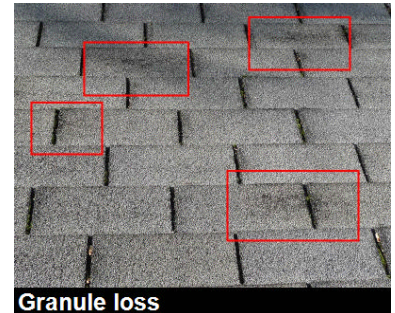
Granule loss

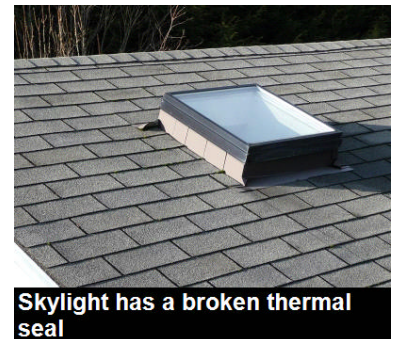
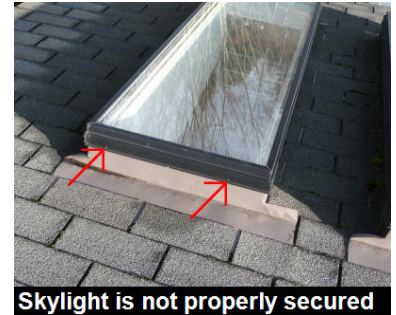
There are 3 skylights installed. All 3 are loose and not properly attached to the skylight curb. The smaller skylight has a broken thermal seal and should be replaced. All 3 skylights need to be properly secured to the skylight curb(s).

Skylight has a broken thermal seal

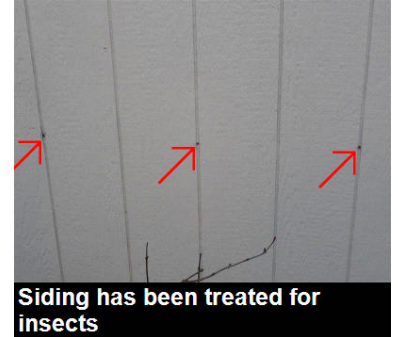
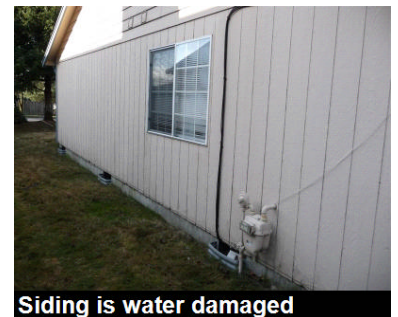
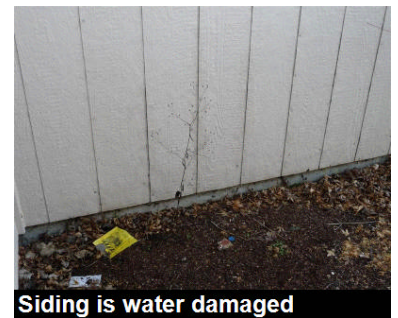
Composite Fiberboard Panels, **Action Necessary** - The LP siding installed on the home is damaged beyond repair and in need of replacement. There is also evidence (drill holes around the exterior of the home into the wall voids) of treatment by a pest control company.

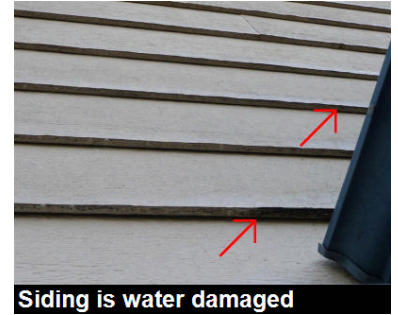
Siding is water damaged

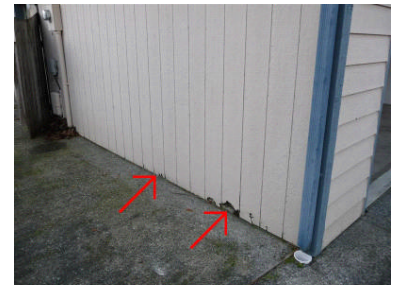
Siding is water damaged

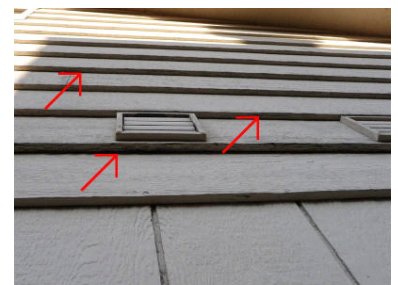
Siding is water damaged/checking

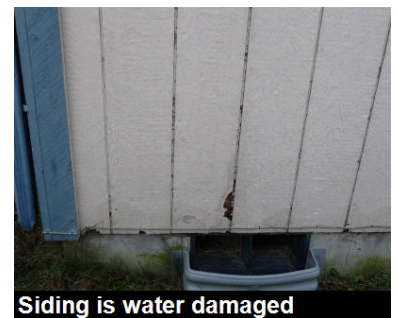
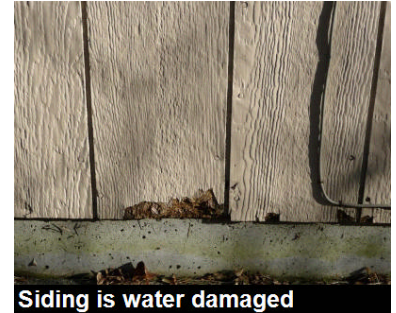
Siding is water damaged

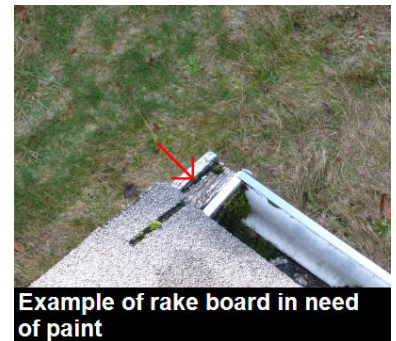
Attention Needed - The fascia and/or rake boards appear to need some minor repair(paint) to prevent further deterioration.

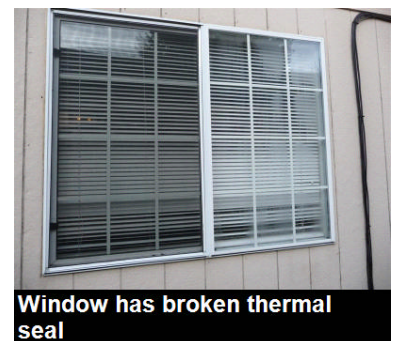
Insulation Seal - One or more insulated glass windows have lost their vacuum seal (bedroom). As a result of losing this seal, condensation between the two panes creates a clouded or streaked appearance. The window still performs the task of keeping the weather out, but it has lost much efficiency.

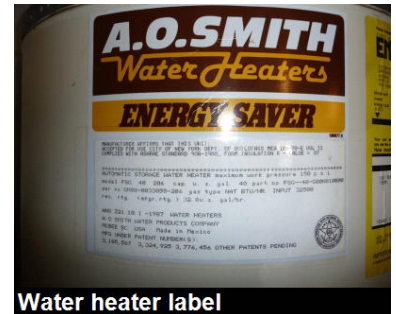
**Water heater label****Tank Capacity:**

There is an AO Smith gas fired water heater installed in the garage. The water heater is 21 yrs old and well beyond the recommended life span of 8-12 yrs. Replacement is recommended.
